**Flood Control Project Maintenance  
Levee Inspections**  
**LMA District Cover Sheet**  
**Spring 2017 Levee Inspection Results**

**Tehama County Flood Control and Water Conservation District**

**Spring 2017 Levee Inspection Results**

Waterway			Bank	Unit Miles
Unit No. 01 Deer Creek			Left	4.22
	Spring (March - May)	Summer (June - August)	(September - November) Fall	Winter (December - February)
Unit Maintenance Rating (Fall Only)				
Date of Inspection	4/25/2017 - 4/25/2017			
DWR Inspector	Bob Duffey			
Accompanied By	Ryan Teubert Tehama County

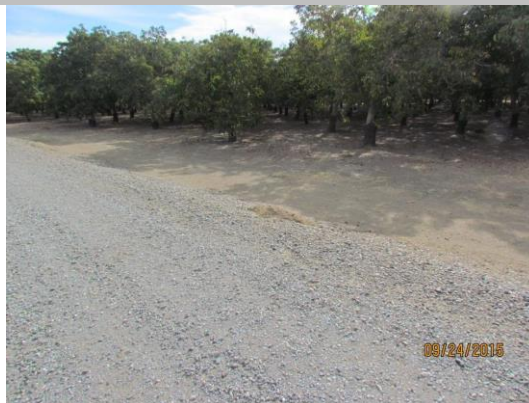
Photo 1 of 1 : SP\_2017\_NA0019\_82\_8\_20170315\_00003.jpg

LM Start	0.94	Rating **	A/W	Issue No.	8
LM End	1.05	Issue Type +	Ma	Location *	LS
Category	Earthen Levee			GPS Latitude/Longitude	
				Start	End
Item	Animal Control			40.051360 °	40.052361 °
				-122.175063 °	-122.173450 °
DWR ID	DWR_NA0019_05_f_2015_8				
Comment Code					
A1 : Exterminate rodents and backfill and compact or grout burrows.					
Inspector Comment					
Grout the rodent the holes. Rodents appeared in holes in center of crown and on LS slope on 4/26/16.

View of the rodent holes along the landside slope.

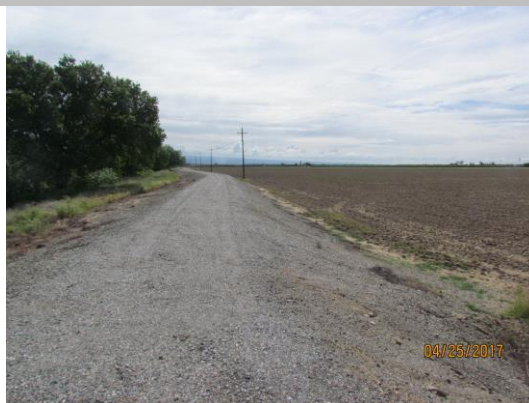
Photo 1 of 1 : SP\_2017\_NA0019\_82\_16\_20170505\_00020.jpg

LM Start	1.28	Rating **	A	Issue No.	16
LM End	1.28	Issue Type +	Ma	Location *	LS
Category	Earthen Levee			GPS Latitude/Longitude	
				Start	End
Item	Vegetation			40.051365 °	40.051365 °
				-122.169852 °	-122.169852 °
DWR ID	DWR_NA0019_05_s_2017_16				
Comment Code					
V1 : Control annual grass and weeds on the levee slopes and easements.					
Inspector Comment					
The vegetation was removed from both slopes.

View of no vegetation on both slopes.

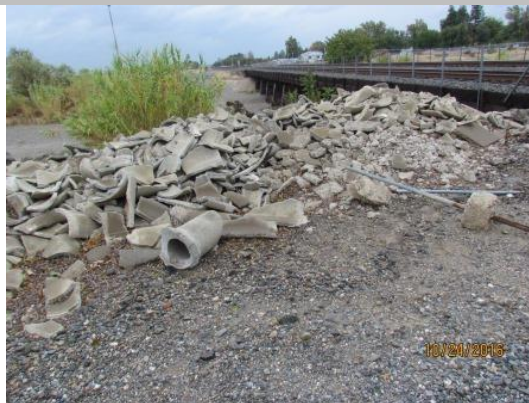
Photo 1 of 1 : SP\_2017\_NA0019\_82\_14\_20170315\_00005.jpg

LM Start	2.41	Rating **	M	Issue No.	14
LM End	2.41	Issue Type +	En	Location *	LS
Category	Earthen Levee			GPS Latitude/Longitude	
				Start	End
Item	Encroachments			40.051274 °	40.051274 °
				-122.150113 °	-122.150113 °
DWR ID	DWR_NA0019_05_f_2016_14				
Comment Code					
DE : Debris					
Inspector Comment					
Pile of broken concrete pipes on the waterside.

View of the broken pipes along the waterside slope.

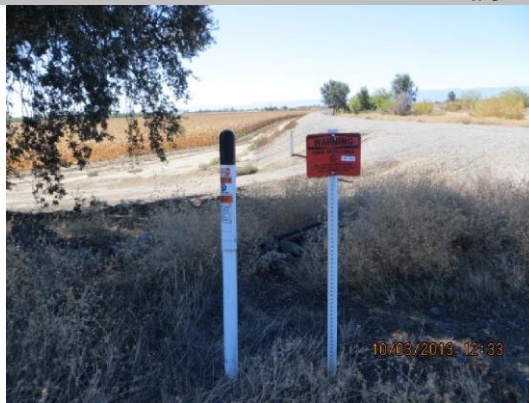
Photo 1 of 2 : UCIP\_SP\_2017\_23052\_39137.jpg

LM Start	2.41	Rating **	M	Issue No.	22
LM End	2.41	Issue Type +	En	Location *	LS
Category	Supplemental			GPS Latitude/Longitude	
				Start	End
Item	DWR UCIP Field Study			40.051336 °	40.051336 °
				-122.149991 °	-122.149991 °
DWR ID					
Comment Code					
Inspector Comment					
FS_ID:23052 DS_ID:24692 EP_NO: N/A Repair Type: Non-Urgent Crossing Status: Found UCIP Comments: No permit identified for this crossing. FIELD_STRUCT_DESC: Underground fiber optic line through the levee at an unknown depth. Sign markers on LS shoulder. FS Date: 10/3/2013 9:02:00 AM

Fiber optic line markers on LS shoulder.

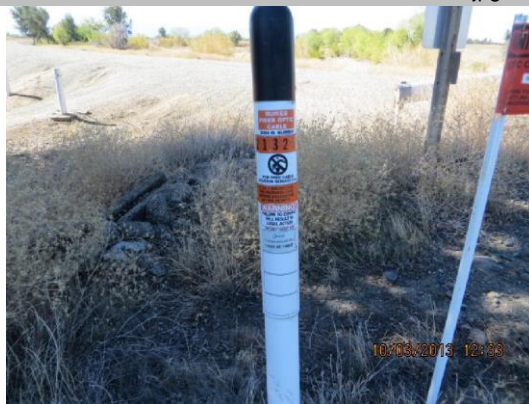
Photo 2 of 2 : UCIP\_SP\_2017\_23052\_39136.jpg

Fiber optic line markers on LS shoulder.

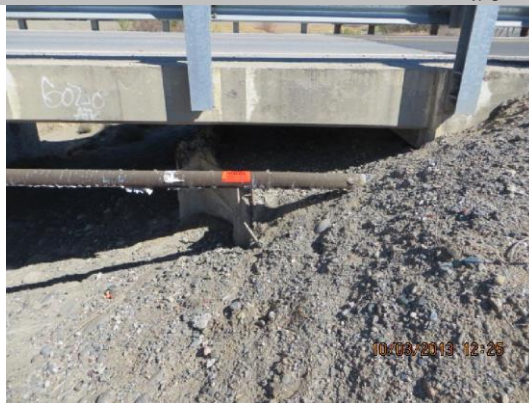
Photo 1 of 3 : UCIP\_SP\_2017\_23044\_39104.jpg

LM Start	2.47	Rating **	M	Issue No.	23
LM End	2.47	Issue Type +	En	Location *	LS
Category	Supplemental			GPS Latitude/Longitude	
				Start	End
Item	DWR UCIP Field Study			40.051667 °	40.051667 °
				-122.149033 °	-122.149033 °
DWR ID					
Comment Code					
Inspector Comment					
FS_ID:23044 DS_ID:24693 EP_NO: N/A Repair Type: Non-Urgent Crossing Status: Found UCIP Comments: No permit identified for this crossing. FIELD_STRUCT_DESC: 4-inch gasline through the levee 2.5-feet below the crown. Pipe visible on upstream side of bridge. FS Date: 10/3/2013

Gasline on upstream side of bridge.

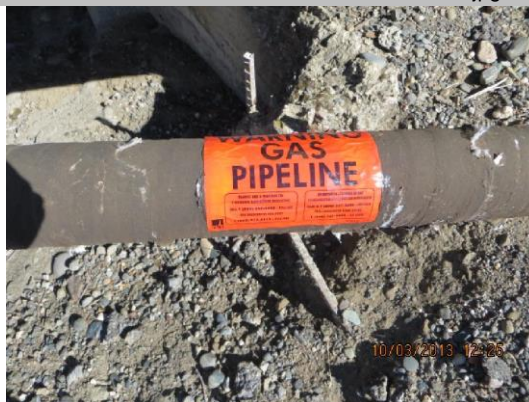
Photo 2 of 3 : UCIP\_SP\_2017\_23044\_39103.jpg

Gasline on upstream side of bridge.

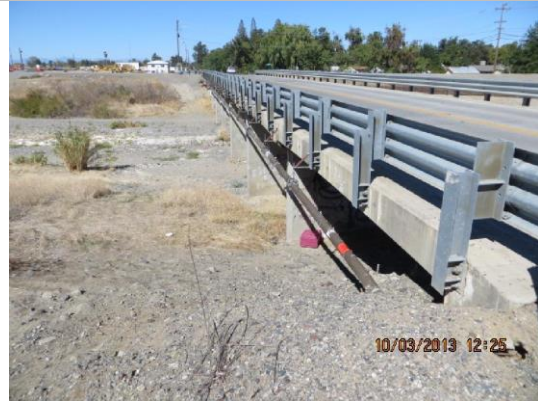
Photo 3 of 3 : UCIP\_SP\_2017\_23044\_39102.jpg

LM Start	2.47	Rating **	M	Issue No.	23 (cont)	
LM End	2.47	Issue Type +	En	Location *	LS	
Category	Supplemental			GPS Latitude/Longitude		
				Start	End	
Item	DWR UCIP Field Study			40.051667 °	40.051667 °	
				-122.149033 °	-122.149033 °	
DWR ID						
Comment Code						
Inspector Comment						
FS_ID:23044						
DS_ID:24693						
EP_NO: N/A						
Repair Type: Non-Urgent						
Crossing Status: Found						
UCIP Comments: No permit identified for this crossing.						
FIELD_STRUCT_DESC: 4-inch gasline through the levee 2.5-feet below the crown. Pipe visible on upstream side of bridge.						
FS Date: 10/3/2013

Gasline on upstream side of bridge.
